Paper No.  
**525**

# **CORROSION93**

## THE INTERRELATIONSHIP BETWEEN MARINE BIOFOULING AND CATHODIC PROTECTION

Brenda J. Little and Patricia A. Wagner  
Naval Research Laboratory  
Stennis Space Center, MS 39529-5004

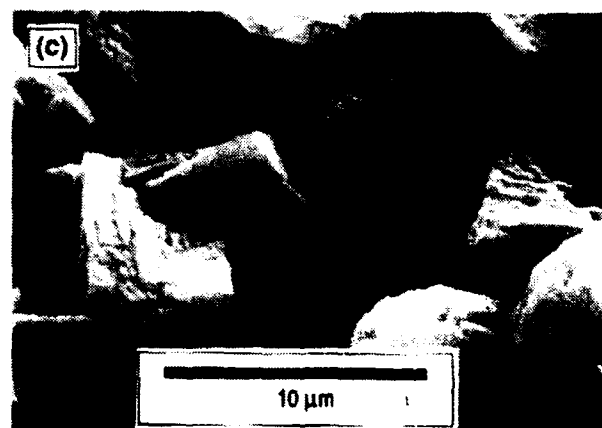
FIGURE 3 – (a), (b) calcareous deposits on polarized titanium (grade 2) after 43 days, and (c) bacteria between calcareous deposits

In the following discussion all potentials have been reported in reference to a saturated calomel electrode (SCE). It has been reported that CP retards microbial growth because of the alkaline pH generated at the surface by reactions (1) and (2). Littauer and Jennings retarded biofouling in seawater using pulsed cathodic polarization of steel.<sup>6</sup> Dhar demonstrated that a potential more negative than -1024 mV was effective in decreasing bacterial content on titanium in seawater by 1 to 2 orders of magnitude.<sup>7</sup> The author concluded that in some systems it would be possible to prevent fouling and corrosion simultaneously by proper manipulation of the cathodic potential. However, numerous investigators have demonstrated a relationship between marine fouling and calcareous deposits on cathodically protected surfaces. For example, Mansfeld et al. polarized three stainless steels and titanium to -850 mV in natural Pacific seawater and followed the formation of surface layers using electrochemical impedance spectroscopy (EIS) and environmental scanning electron microscopy.<sup>8</sup> The applied potential was removed the day before EIS measurements, so that EIS data were collected at  $E_{\text{corr}}$  in a frequency range between 65 kHz and 10 or 1 mHz with a signal amplitude of 10 mV. Calcareous deposits and bacteria were evident on the surface after 5 days. Areal coverage of the surfaces could be followed with EIS (Figure 1a). For an exposure time of 5 days EIS data were similar for polarized and unpolarized samples (Figure 1b) despite the occurrence of scattered calcareous deposits on the polarized surface. After 13 days there were two time constants in EIS spectra of polarized samples indicating two surface conditions i.e., covered and uncovered. The occurrence of two time constants corresponding to calcareous deposits and uncovered surface is evident in the frequency dependence of the phase angle. After 43 days the time constants were no longer well defined due to complete coverage of polarized surfaces with calcareous deposits (Figure 2). In all cases bacterial cells could be imaged between and on top of calcareous deposits (Figure 3). It is noteworthy that the size and shape of calcareous deposits on polarized titanium differed from those on polarized stainless steel.
